# Manhole Inspection Summary

Manhole # S63Y\_\_002MH

**Inspection** ☐ Is Incomplete Rating: **3) Fair**

**Location** Address: **Keith Ave. on railroad tracks.**

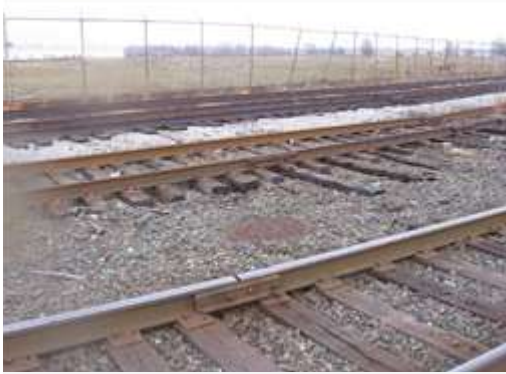
Location View

Comments **CITY OPENED MANHOLE. 7/21/08. ON RAILROAD BETWEEN TWO TRACK LINES.**

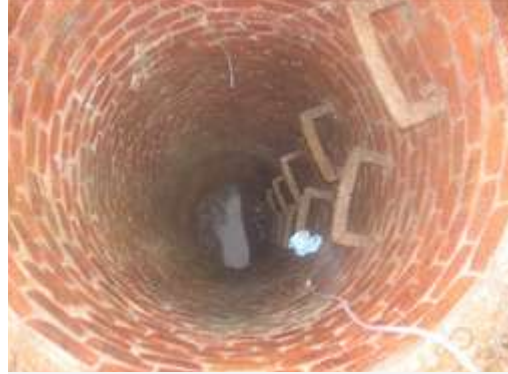
Top View

Condition: **Worn**

**Frame** Offset: **3** (in.) Condition: ☒ Sound ☐ Cracked ☐ Leaks

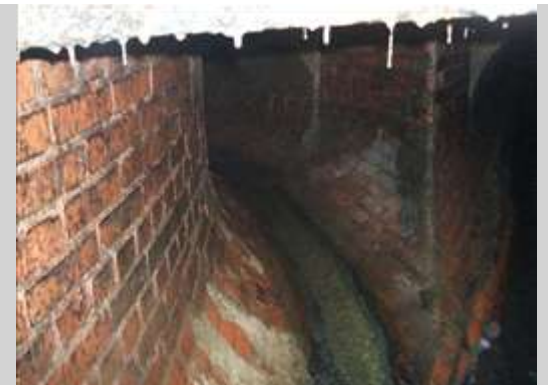
5 O'Clock Inflow

42 in. Circular Gravity Sewer  
Pipe In @ 5 O'Clock

Pipe Height: **42** (in.) Rod and Bar (Angled)  
Pipe Material: **Concrete** ☐ Pipe Lined  
Invert Depth: **29.25** (ft.) Flow Characteristics: **Slow**  
Deposits: ☒ None ☐ Mud ☐ **Sludgy** ☐ Debris ☐ Grease  
Silt Depth: (in.) Deposits Extent:  
Infiltration: **None** Pipe Seal Cond: **Sound**

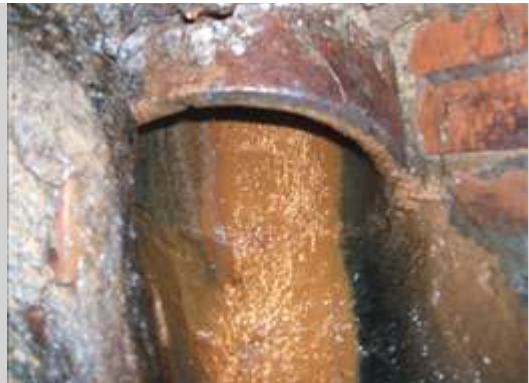
9 O'Clock Inflow

12 in. Circular Gravity Sewer

Pipe Height: **15.6** (in.) Rod and Bar (Angled)

Infiltration: **None** Pipe Seal Cond: **Sound**
